HP Multifunction Finisher, Color LaserJet 9500, 9500mfp, LaserJet 9000, 9000mfp, 9040mfp, and 9050mfp Series Printers - How to Resolve 66.12.36 Errors

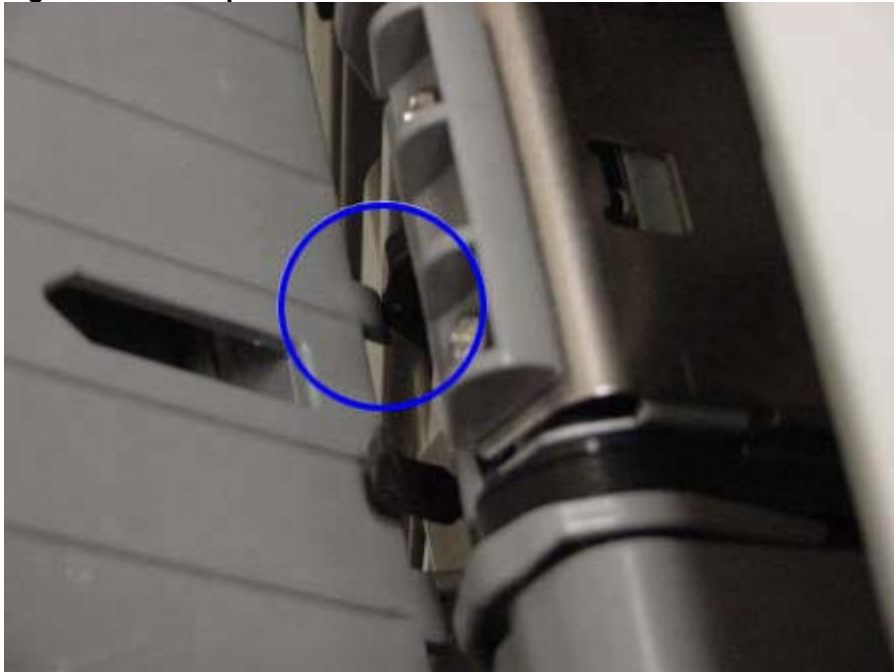
Figure 1: Correct position

1. Make sure that the stacker bin presses the paper-level sensor flag and activates the paper-surface sensor (P19), see the figure below.

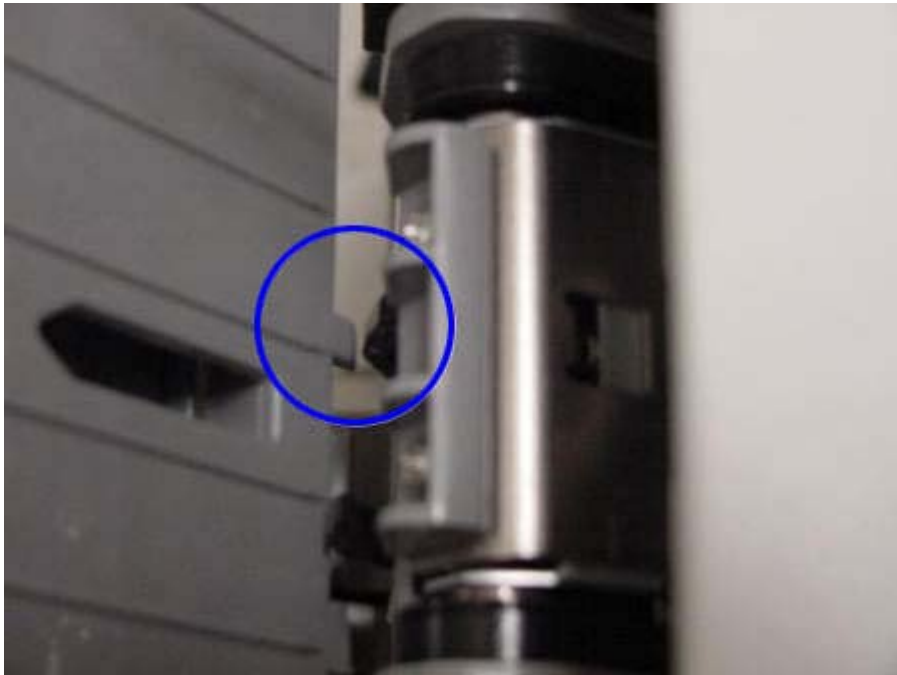
Figure 2: Incorrect position

HP has identified a primary reason for 66.12.36 errors caused by the HP Multifunction Finisher (MFF). This error can be caused during shipping, if the Finisher is not properly re-packaged or moved in a proper manner. In this situation, the 66.12.36 error is caused by the face down bin being bent, causing the paper-level sensor flag to not contact the paper-surface sensor.

2. If it does not, then check the stacker bin to make sure that it is not bent in the upward position, see the figure below.
